Enhanced fixation of uncemented knee replacement with hydroxyapatite

Keywords: Hydroxyapatite, Total Knee Replacement, Fixation

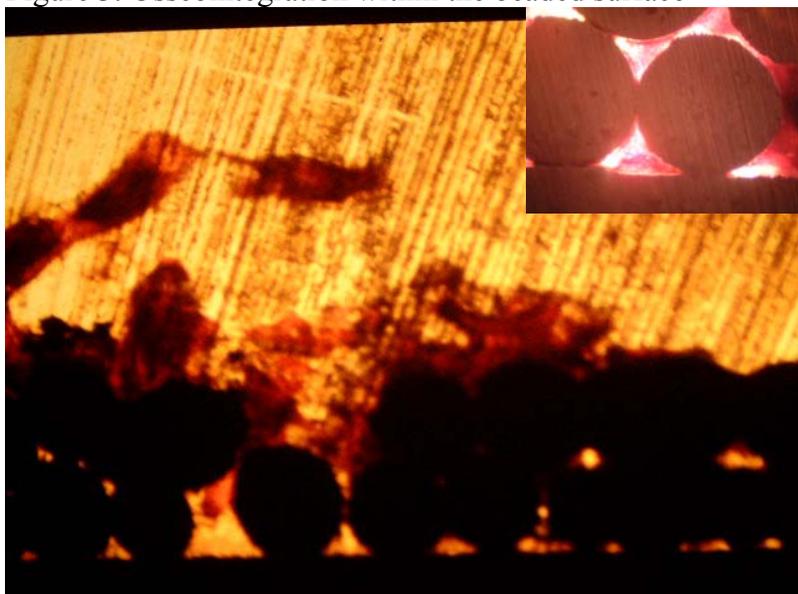
Figure 3. Osseointegration within the beaded surface

There has been suggestion [8] that HA coating of a beaded surface can lead to bead shedding and possible third body wear. None has been seen in this study, although it was specifically examined for. The prosthesis used has beads only on the distal femoral surface, where there should be no shear, and the authors therefore believe that a coated, beaded distal surface should not pose a problem. A retrieval specimen that has been obtained shows osseointegration within the beaded surface (Fig. 3).
